# Inspection Report

Property Address:  
[REDACTED]

2008 Newmar Essex 4515

**RVProPlus**

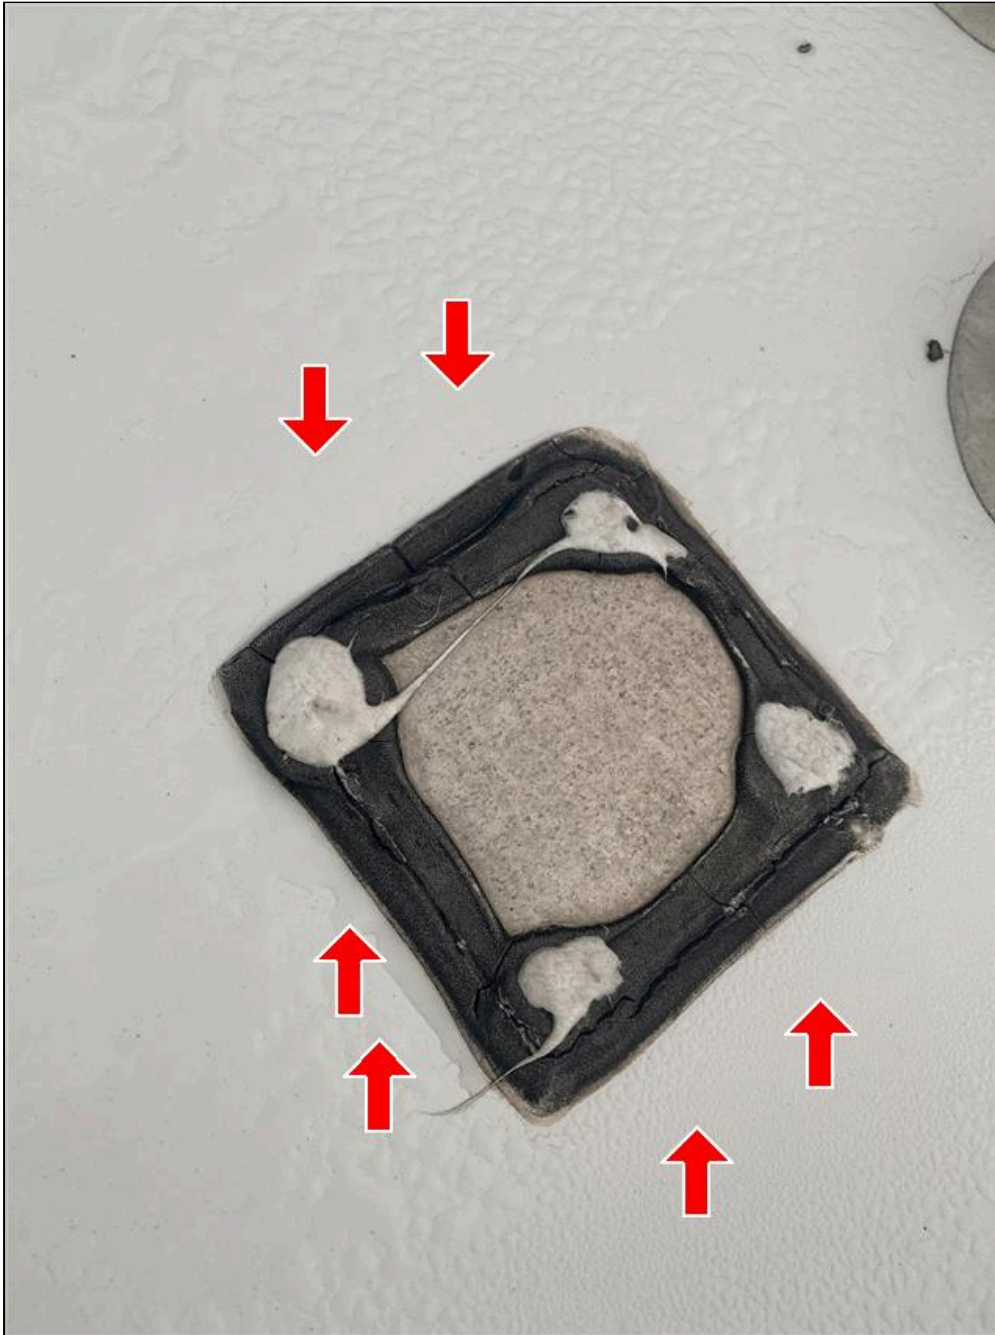
2.8 Item 1(Picture) Vent Cover-Loaced Roof Center Curbside

Plumbing Vent cover needs to be resealed. No ceiling stains or any other evidence of Water Leaks. Recommend a qualified RV Technician re-seal Vent..

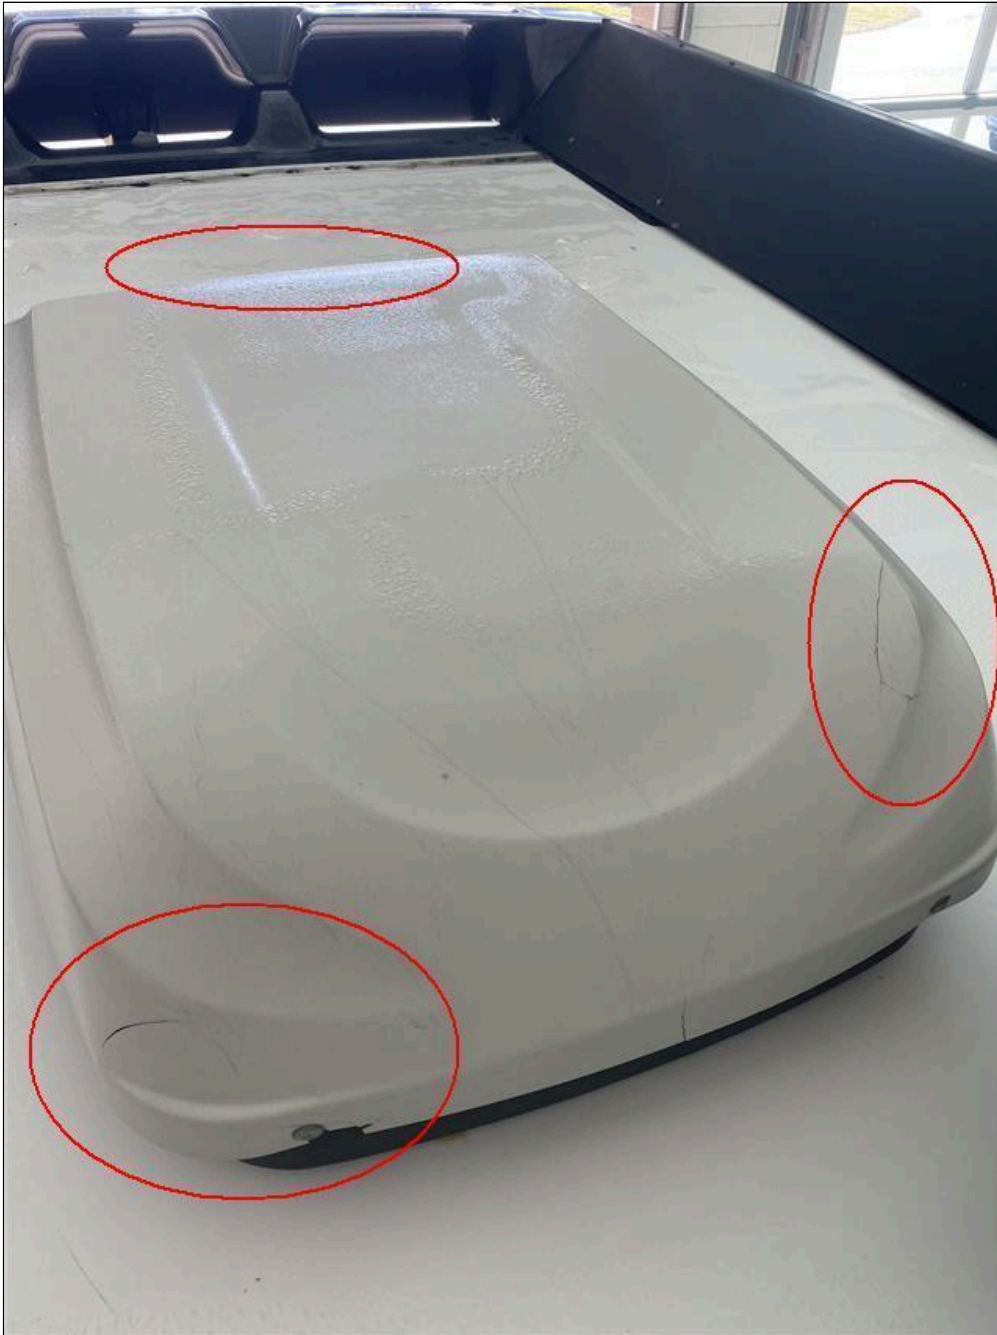
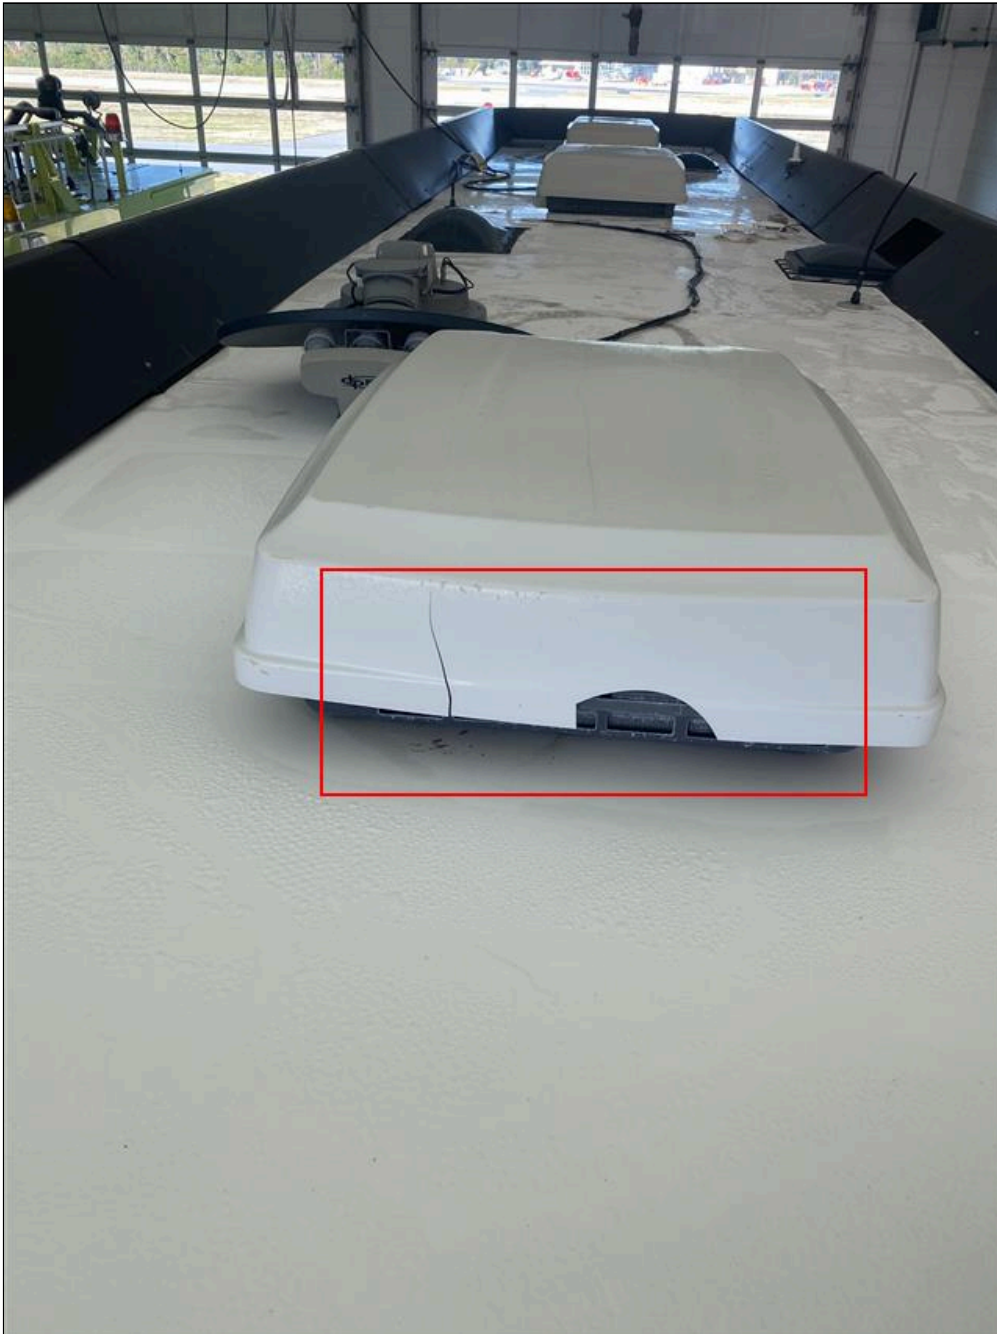
2.15 Item 1(Picture) Rear A/C unit

2.15    Air Conditioner #3 (Shroud)  
    **Poor**  
    Rear A/C shroud has 3 cracks. Shroud could blow off during travel, which may cause a traffic hazard. Recommend a qualified RV technician replace shroud.

18.0.C Air Conditioner Condition  
    **Poor**  
    Rear A/C on Roof Shroud Cracked in 3 Places. Recommend A/C Shroud be checked be a Qualified RV Technician.

Rear A/C on Roof Shroud Cracked in 3 Places. Recommend A/C Shroud be checked by a Qualified RV Technician.

Rear A/C shroud has 3 cracks. Shroud could blow off during travel, which may cause a traffic hazard. Recommend a qualified RV technician replace shroud.

**Comments:** Poor  
Rear A/C on Roof Shroud Cracked in 3 Places. Recommend A/C Shroud be checked be a Qualified RV Technician.

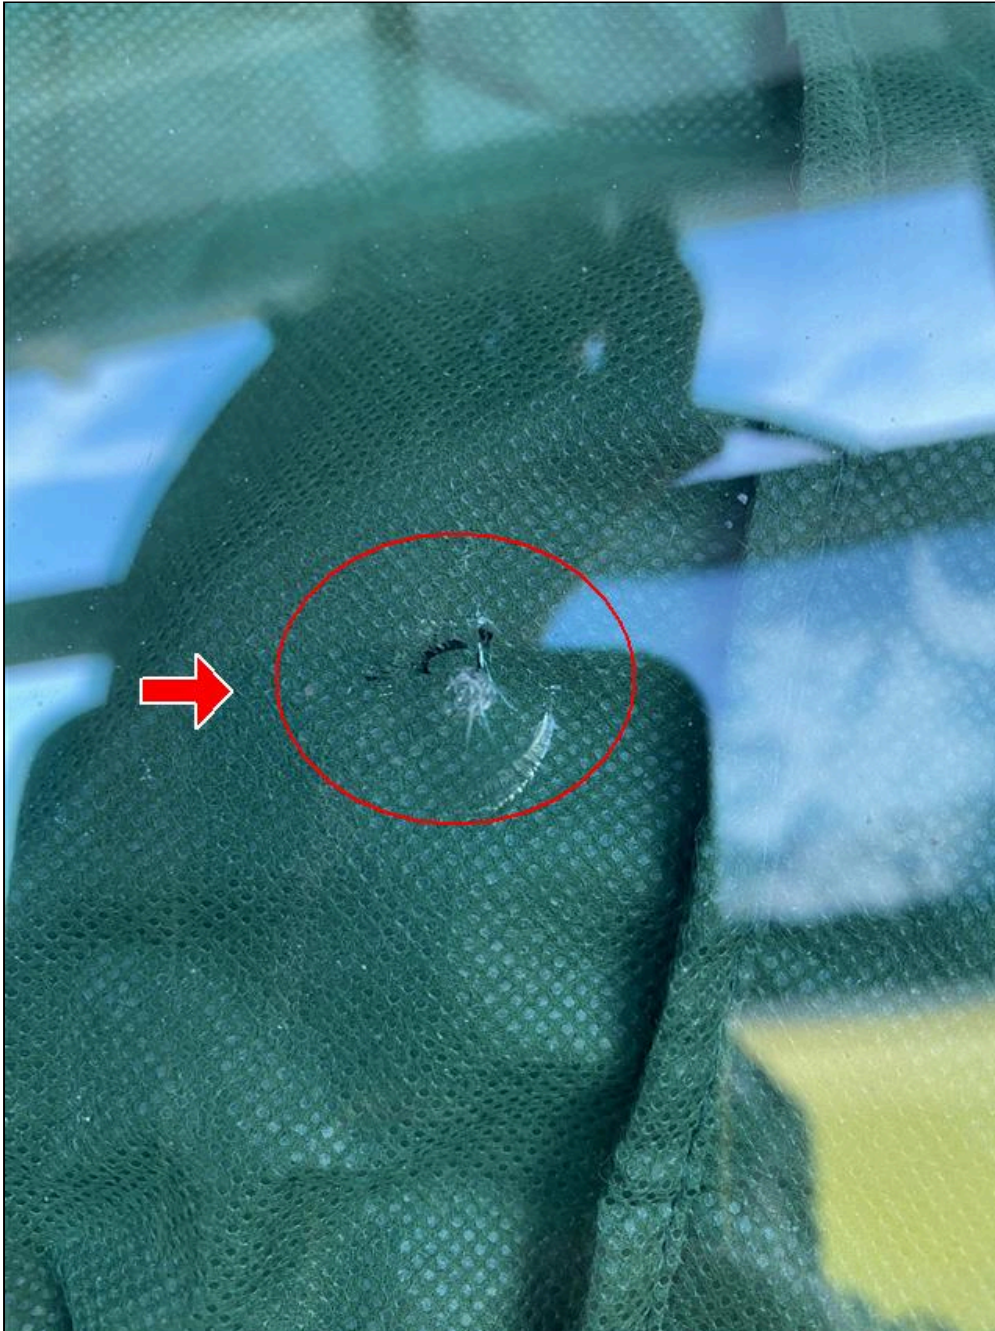
3.1 Item 1(Picture) Small chip in windshield

Small rock like chip in windshield lower center at dash level. Chip is not in line of sight of driver or passenger.

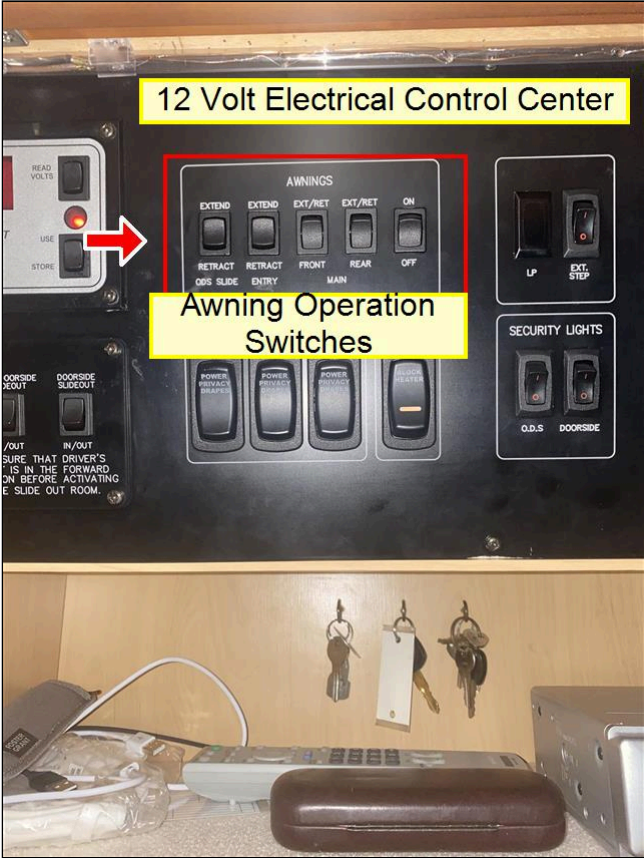
6.2.C Item 1(Picture)

Above door awning did not operate when button on FOB or Above Drivers Cockpit switch inside motor home was pressed. A qualified RV technician is recommended to repair Awning.

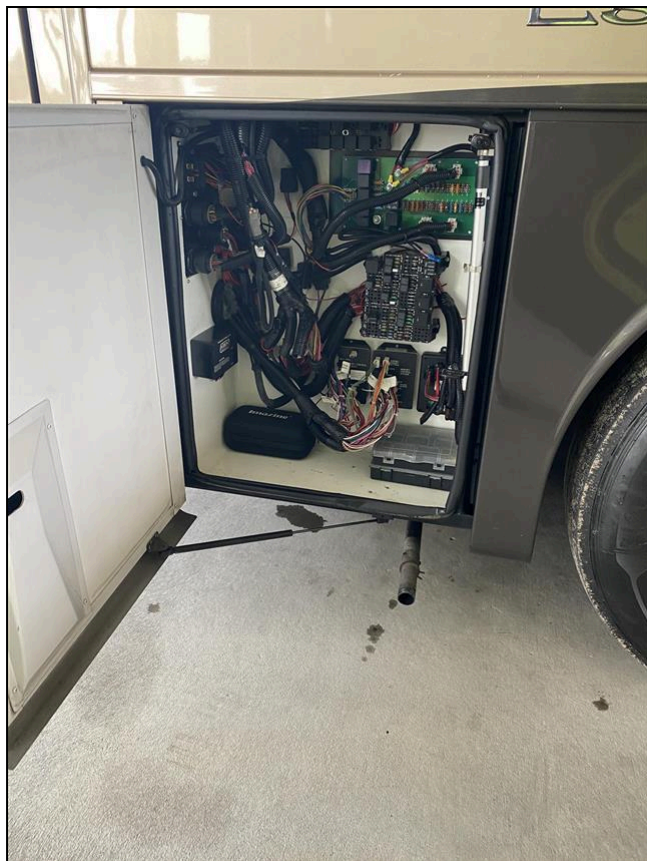
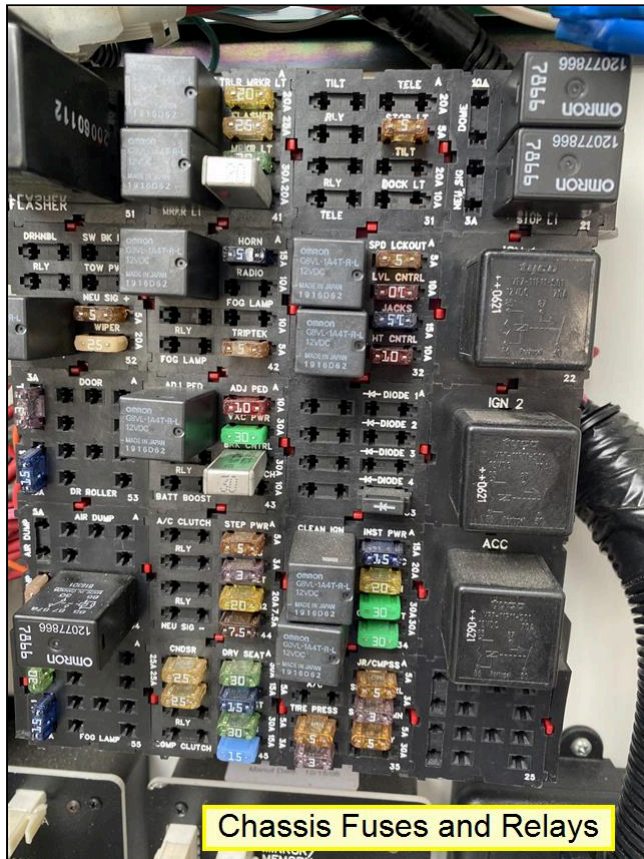
9.0 Item 2(Picture) Chassis Electrical Compartment

Note Water Stain in Chassis Fuse Compartment-( Recommend a qualified RV Technician to check for Repair)

Chassis 12 volt Electrical Access Compartment( Streetside, under Drivers window) All fuses good and wiring and connections secured.

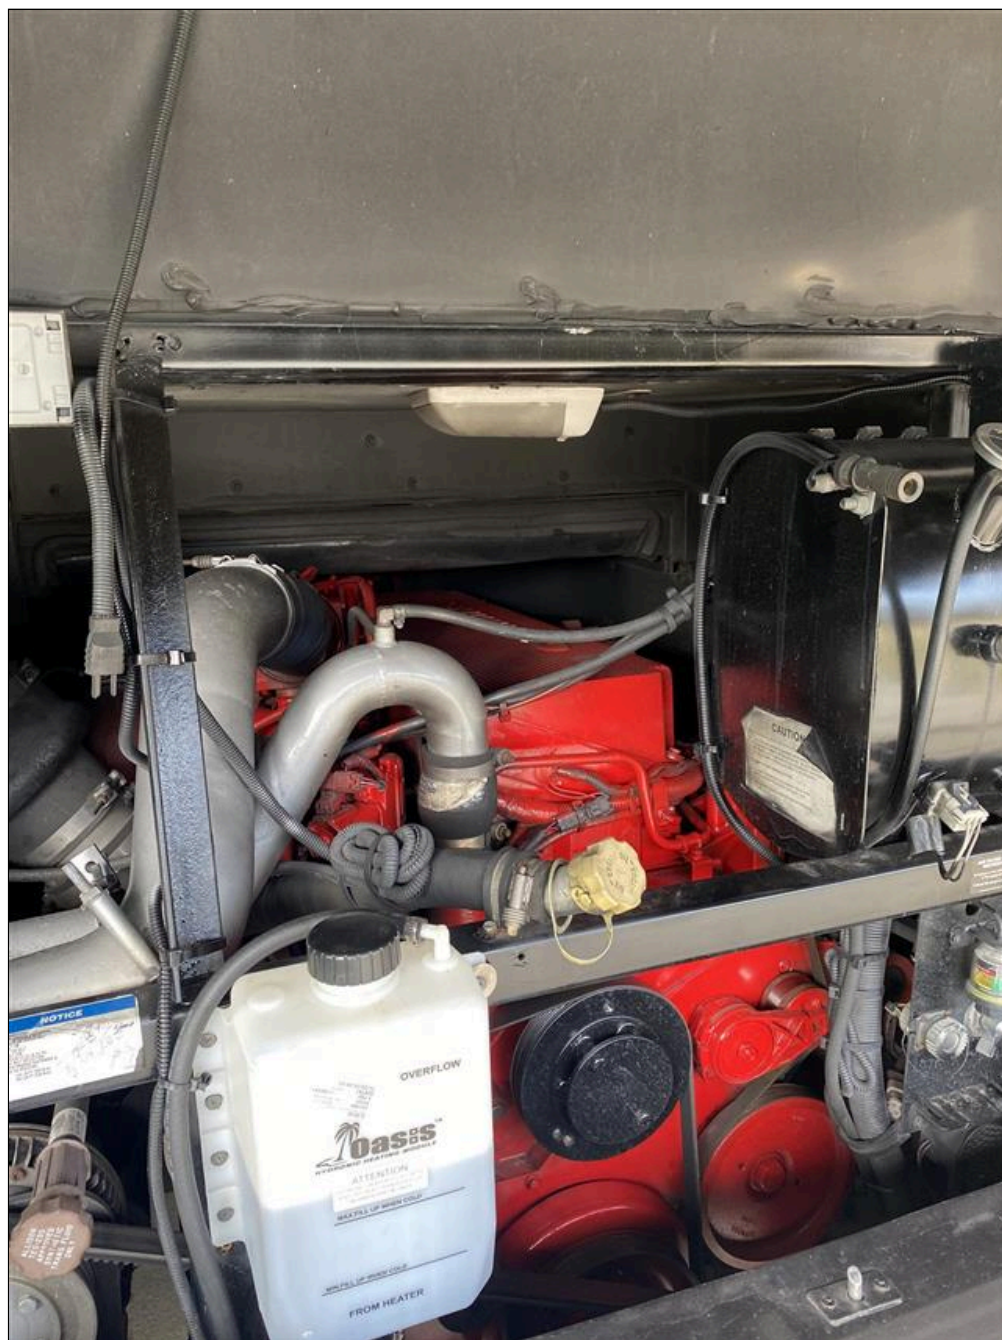
10.0 Item 1(Picture) Engine Overview

ISM 500 Diesel Engine Compartment condition. No signs of oil or fluid leaks. Note: Reservoir in foreground has been replaced per dealer prior to sell.

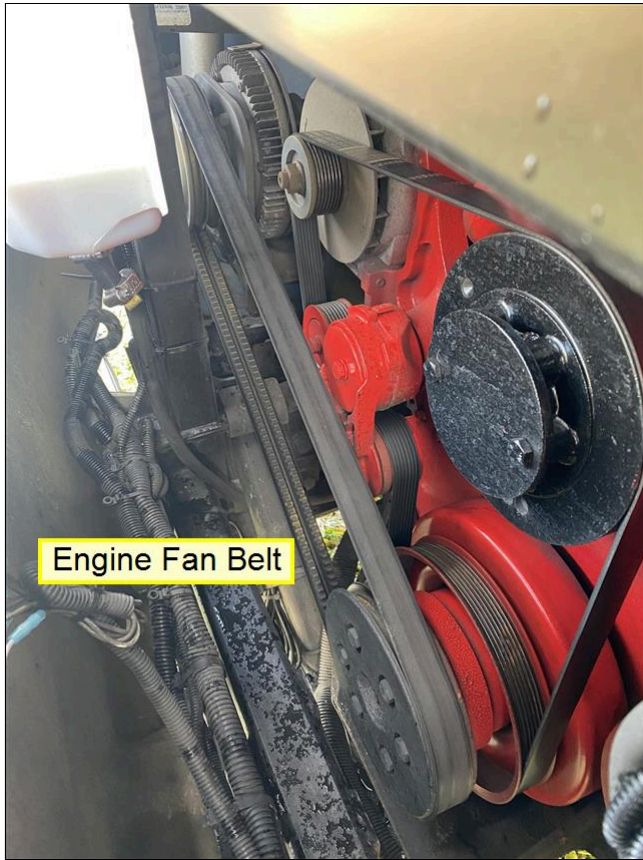
10.2 Item 1(Picture) Engine Fan Belt

Fan Belt for Water Pump, A/C, Alternator, is in Acceptable Condition

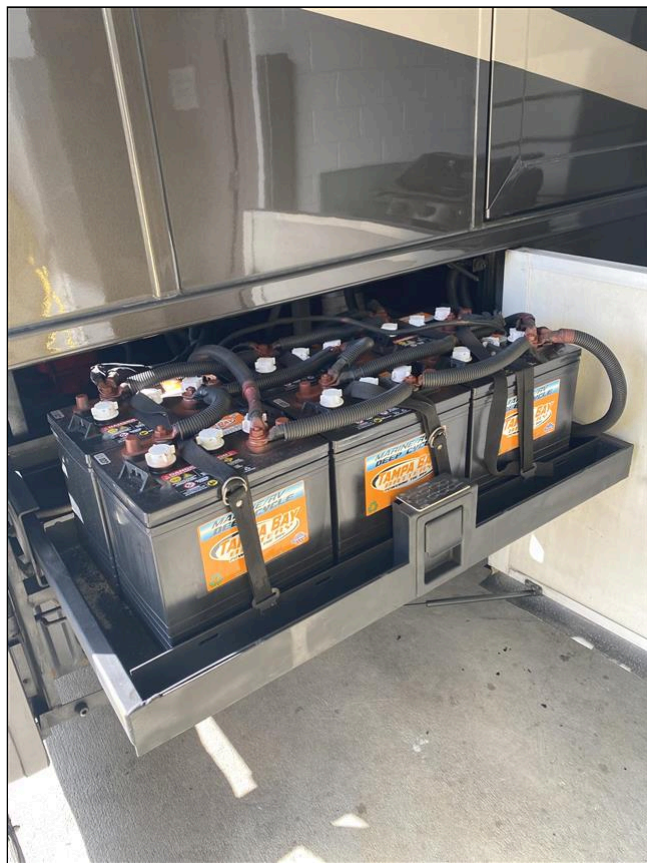
13.39 Item 1(Picture)

All 8- 6 volt batteries were changed out 12/2000. Per Tampa Bay battery store, batteries were manufactured 10/2000.

Not date stamp on top of batteries.
