# Inspection Report

Property Address:  
[REDACTED]

2008 Newmar Essex 4515

**RVProPlus**

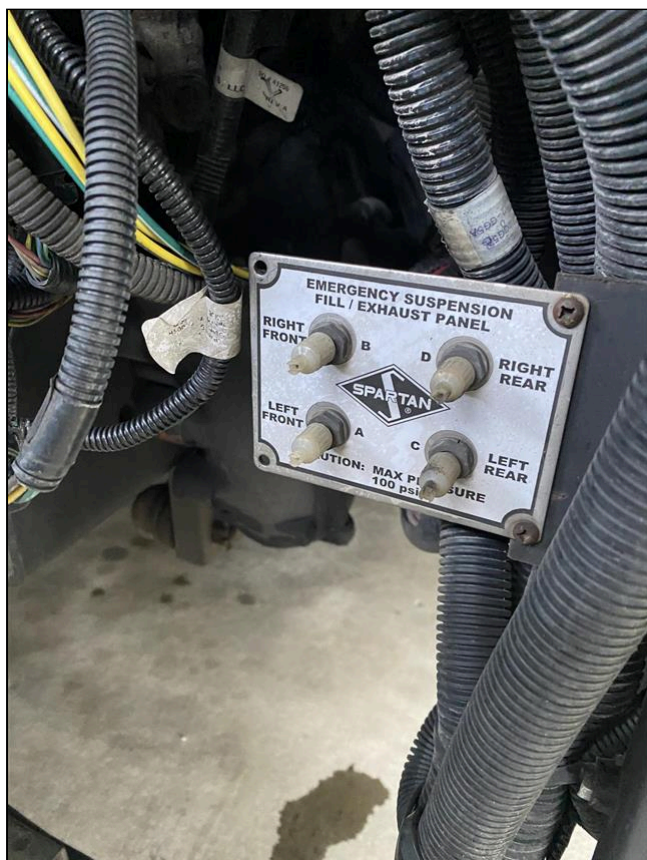
9.4 Item 1(Picture) Spartan Emergency Air Valves

Emergency Air Valves are designed so if air brakes should lock down due to lack of air in the system. Outside air from a compressor can be introduced into brake system to unlock brakes for towing. Unable to Test . For Emergences Only

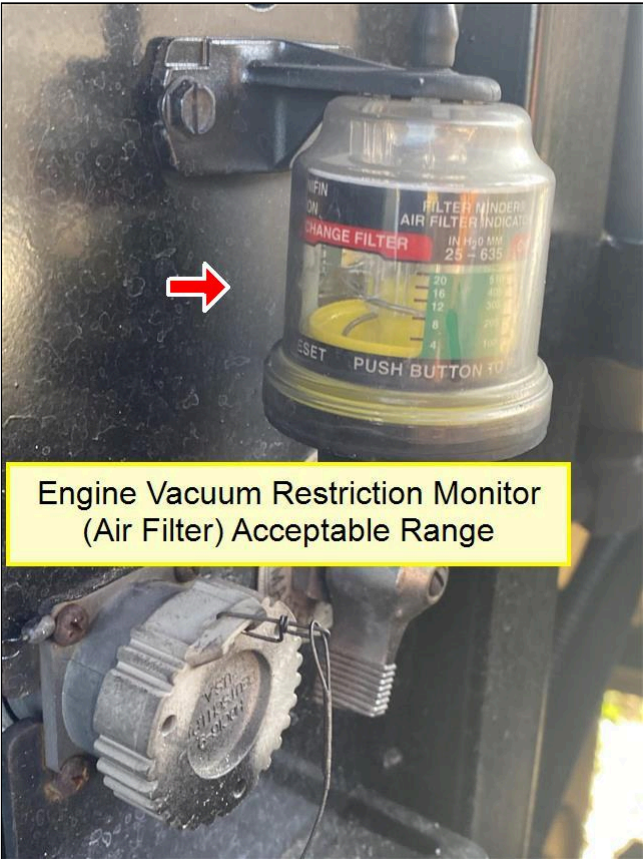
10.0 Item 3(Picture) Air Filter Monitor

Engine Vacuum Restriction Monitor  
(Air Filter) Acceptable Range

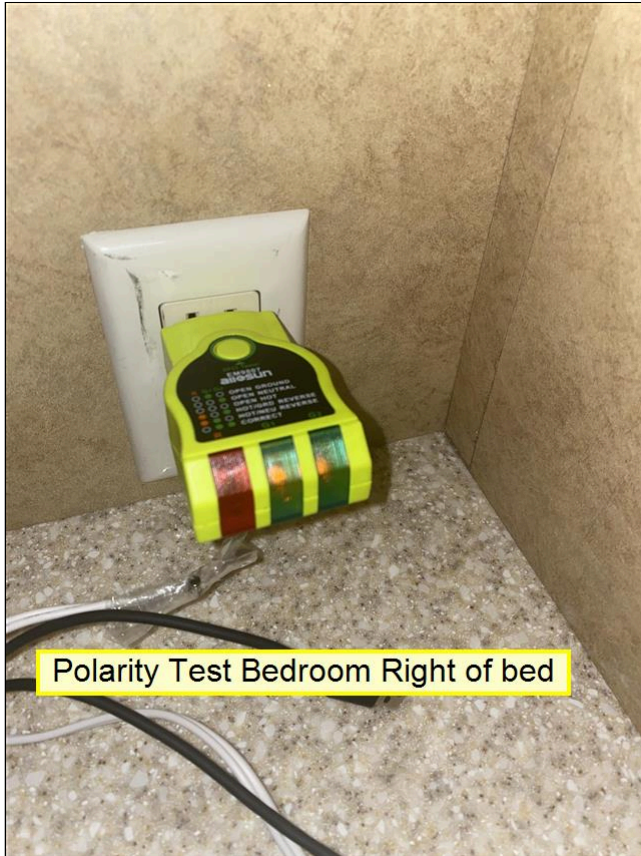
13.14 Item 1(Picture)

Polarity Test Bedroom

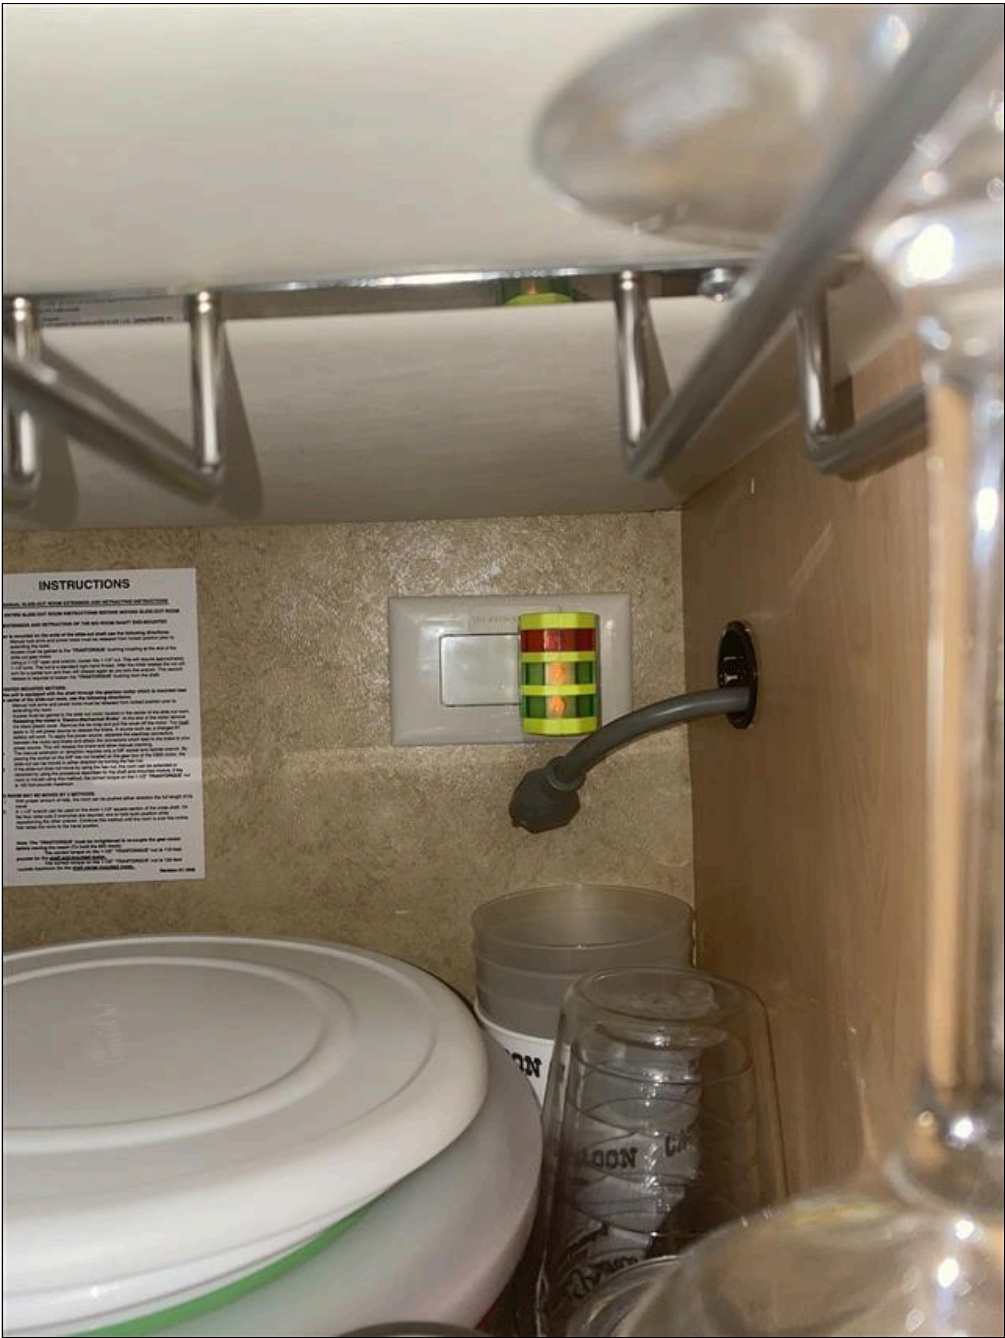
13.16 Item 1(Picture) Microwave/Convection Oven Receptacle

Microwave/Convection Oven Receptacle Polarity Test Passed

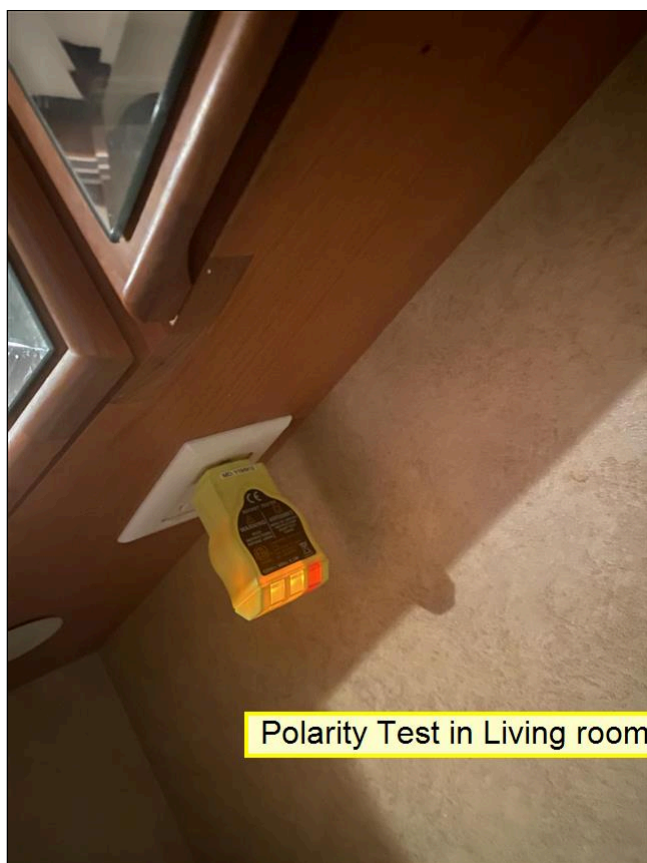
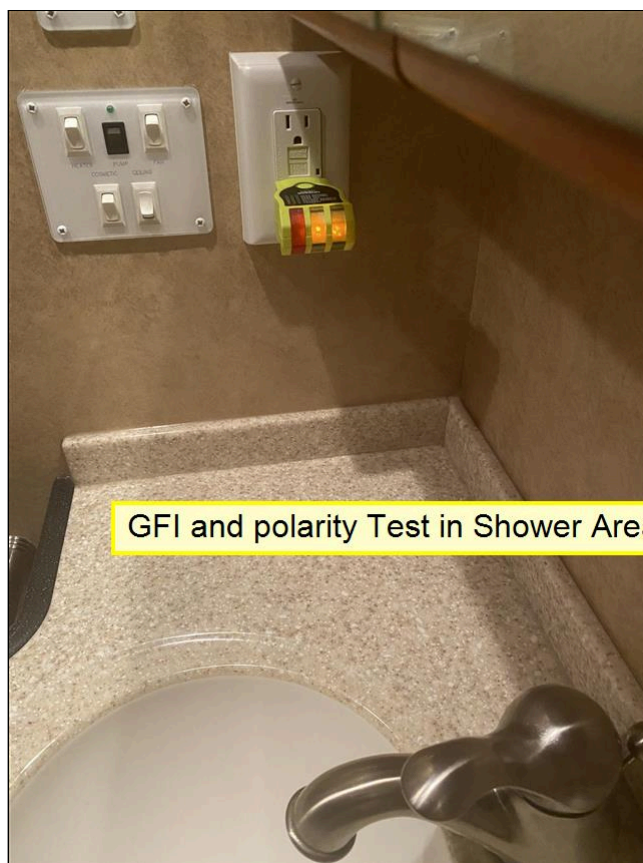
GFI and Polarity Test Passed

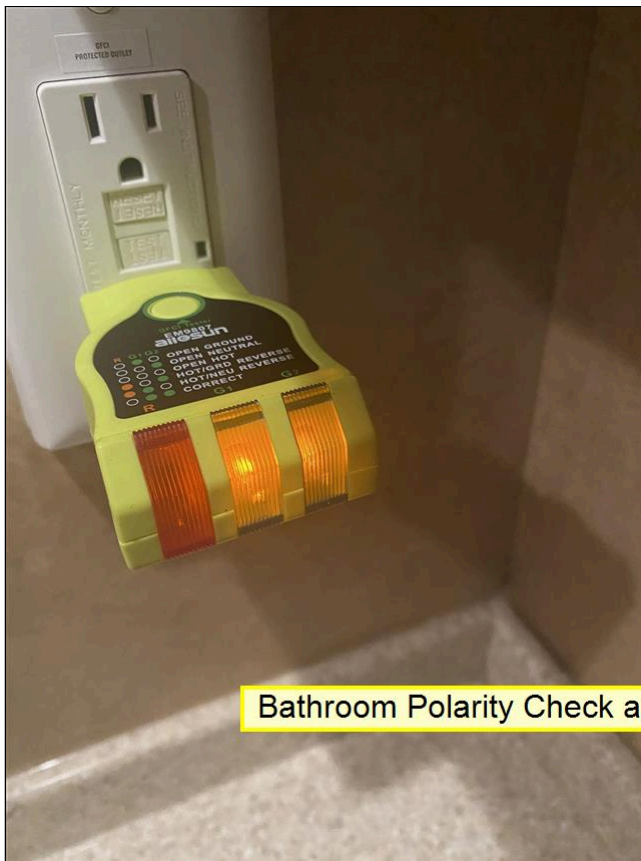
13.19 Item 1(Picture) GFI Receptical in Toilet Area

GFI test results passed.

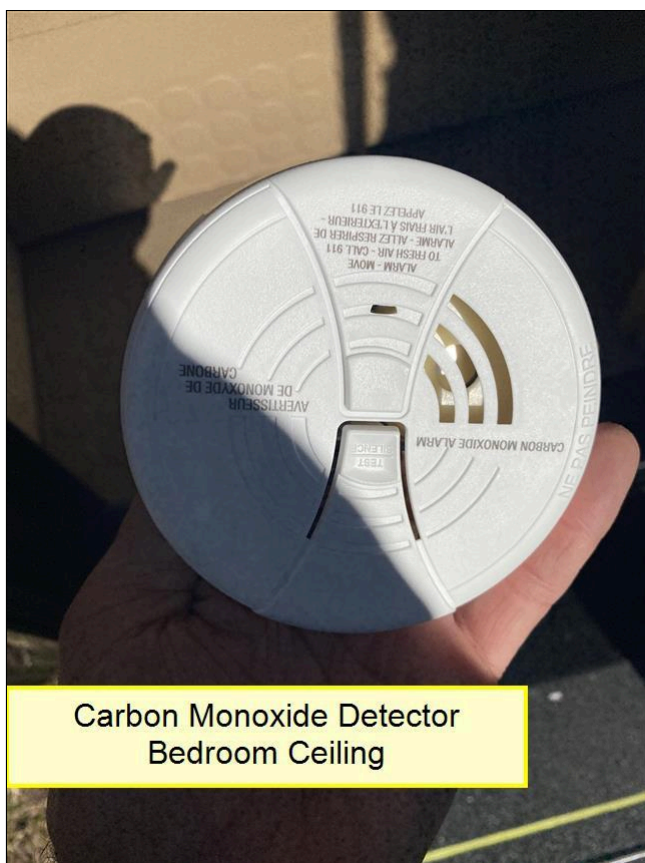
15.0 Item 1(Picture) CO2 Detector

Carbon Monoxide Detector. Date Code: 09/20.

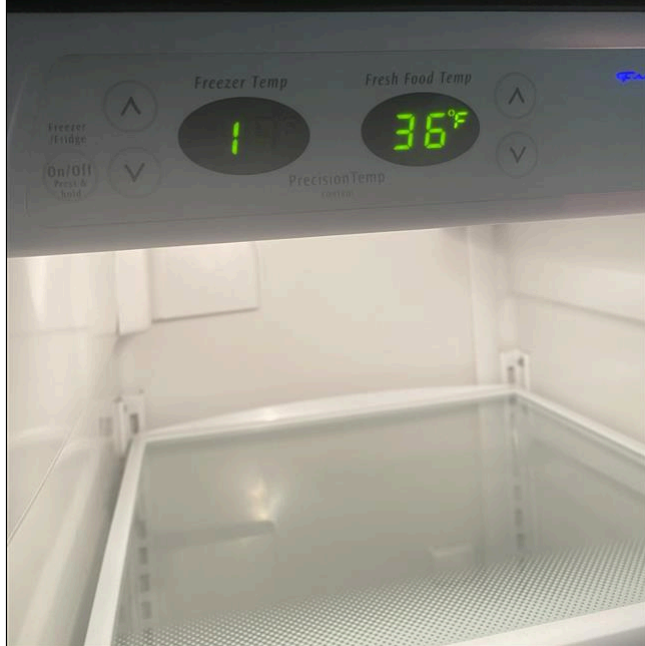
16.3 Item 1(Picture) Frigidaire Refrigerator

Refrigerator and Freezer Temperature Readings after 3 hours being plugged into 120 volt

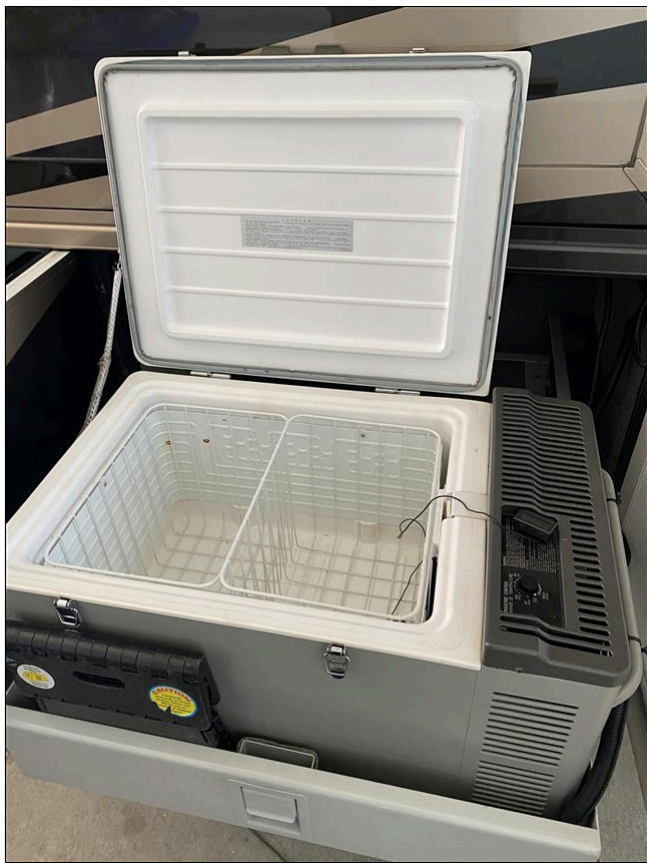
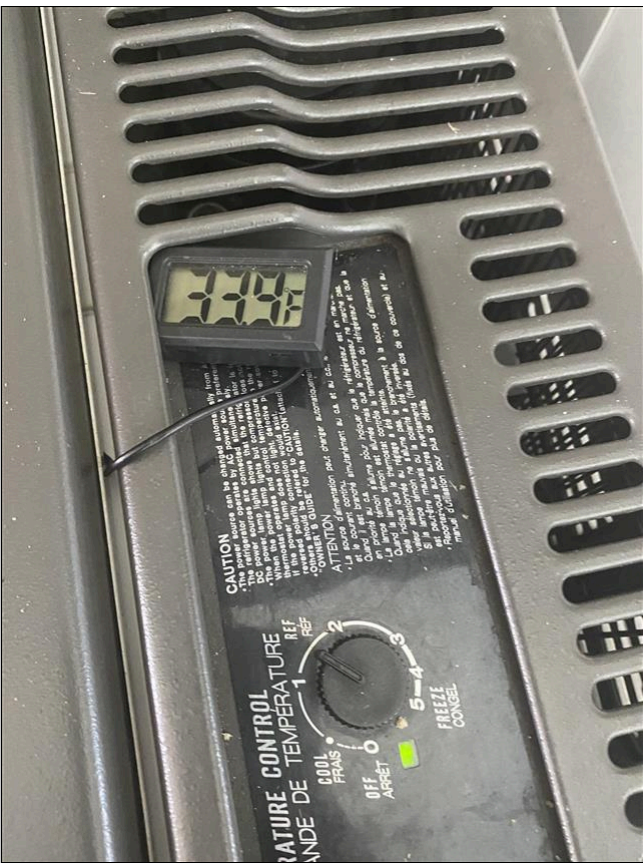
Tested and results were 33.9 degrees at setting 4 after 15 minutes from turning on chest.

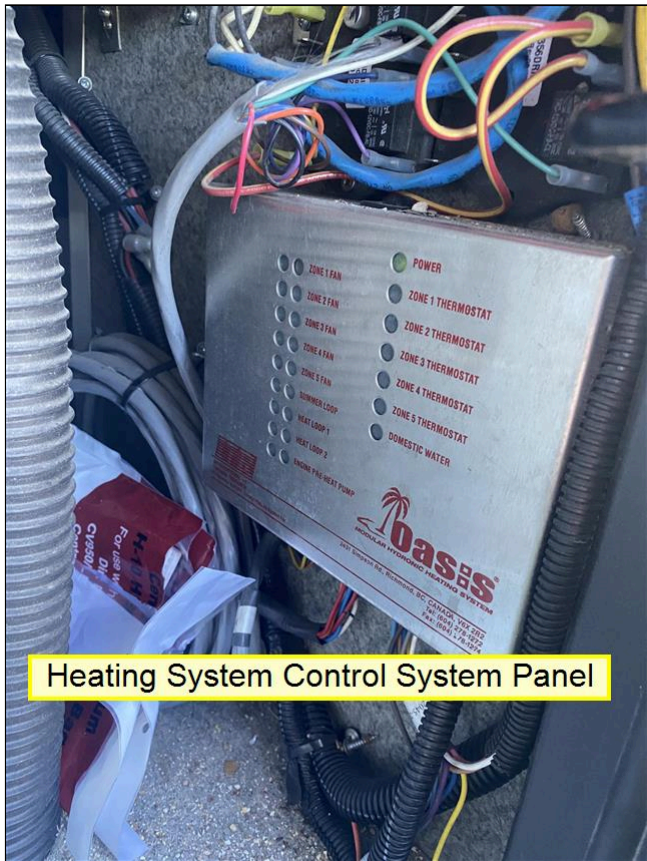
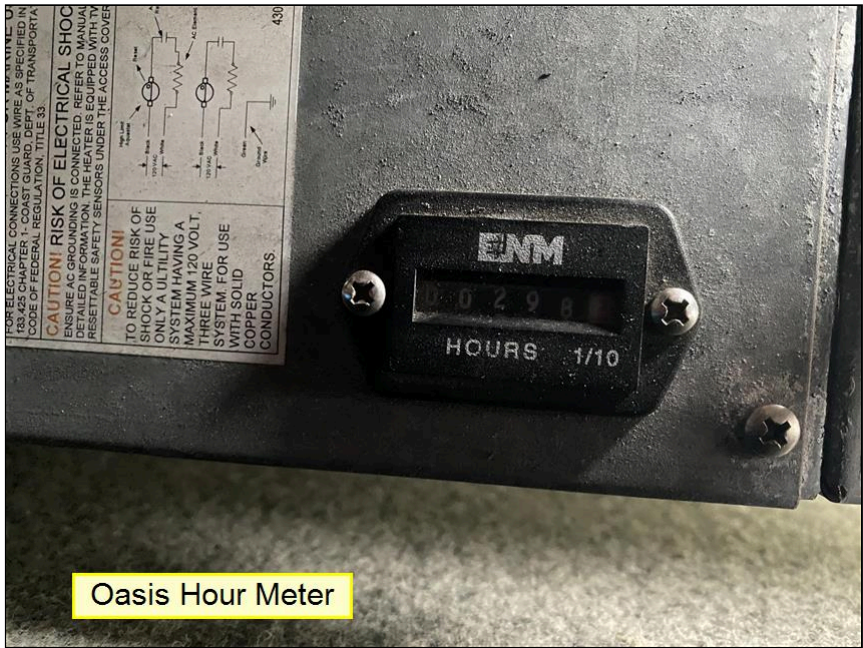
Dealer replaced the Oasis Heating Nozzle, igniter and fuel filter 12/2020

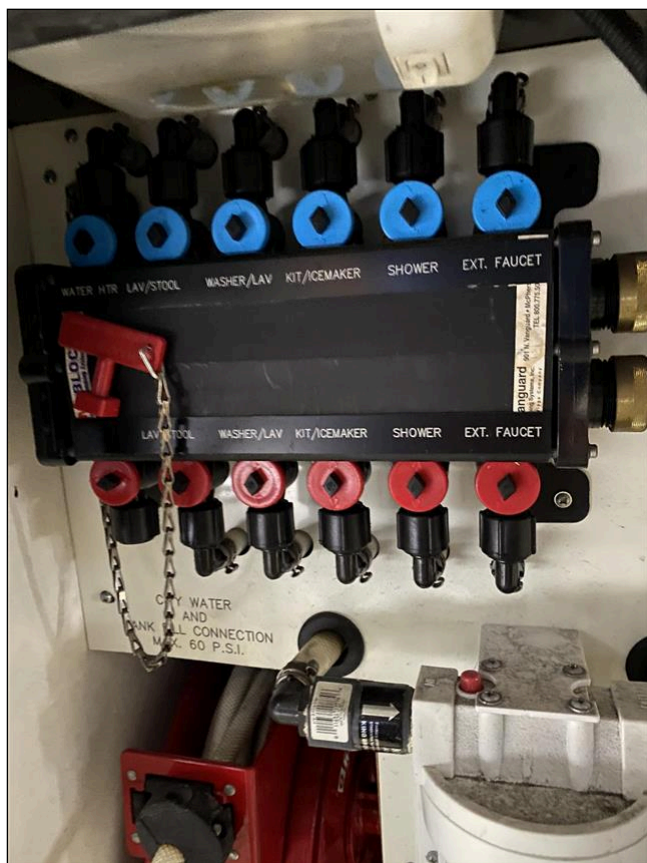
19.73 Item 1(Picture) MonoBlock

This system is designed to shut down various water line in motor home in case of leaks. System was tested and operated as designed, no signs of leaks.

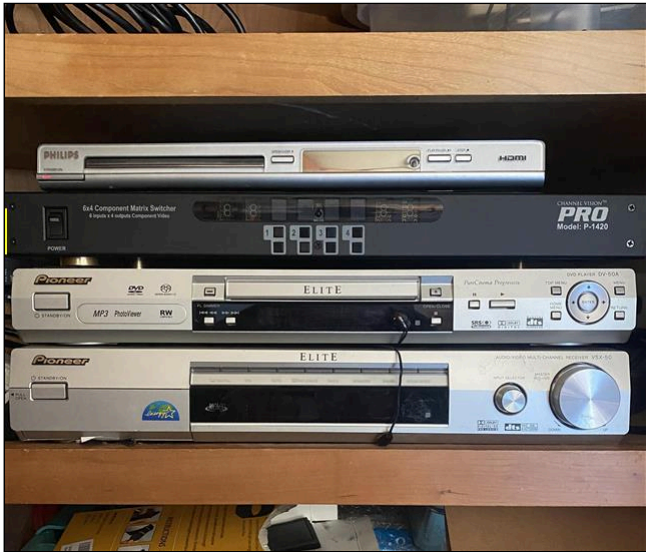
21.0.H Item 1(Picture) Entertainment Components

Comments: Yes  
All Components Tested and Perform as Designed

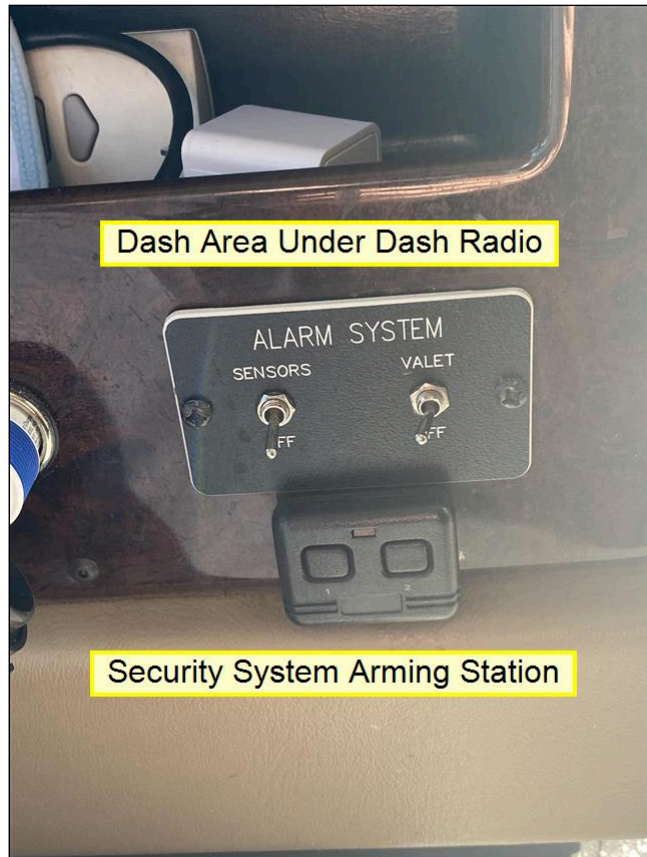
21.0.N Item 1(Picture) Dash Security Arming Switches

Unable to Inspect due to no codes for arming system.

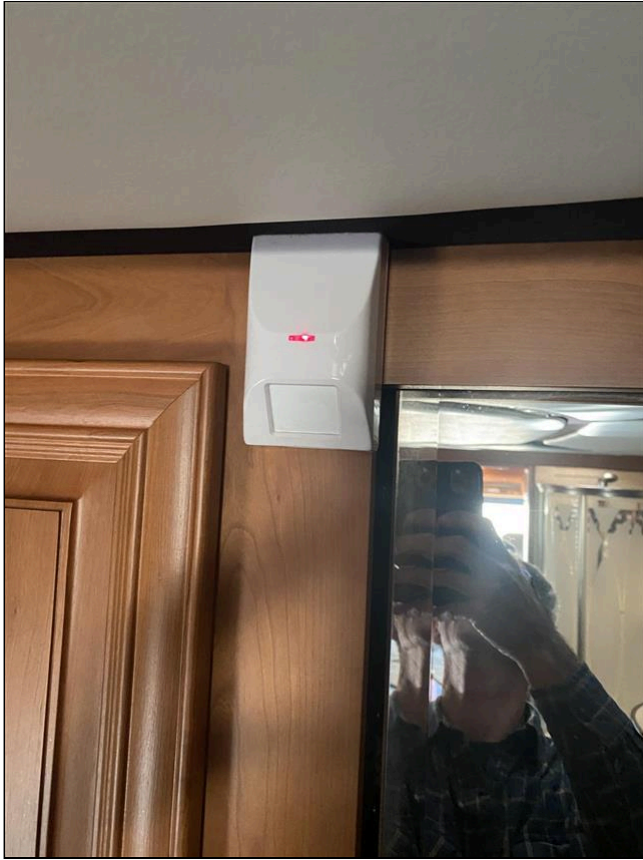
21.2.N Item 1(Picture) Amemco Security System

Passive Infrared Motion Detector
